Key Considerations for the Repair of Structures With Defective Wallboard

James L. Poole, Ph.D., CIH

ENVIRON International Corporation

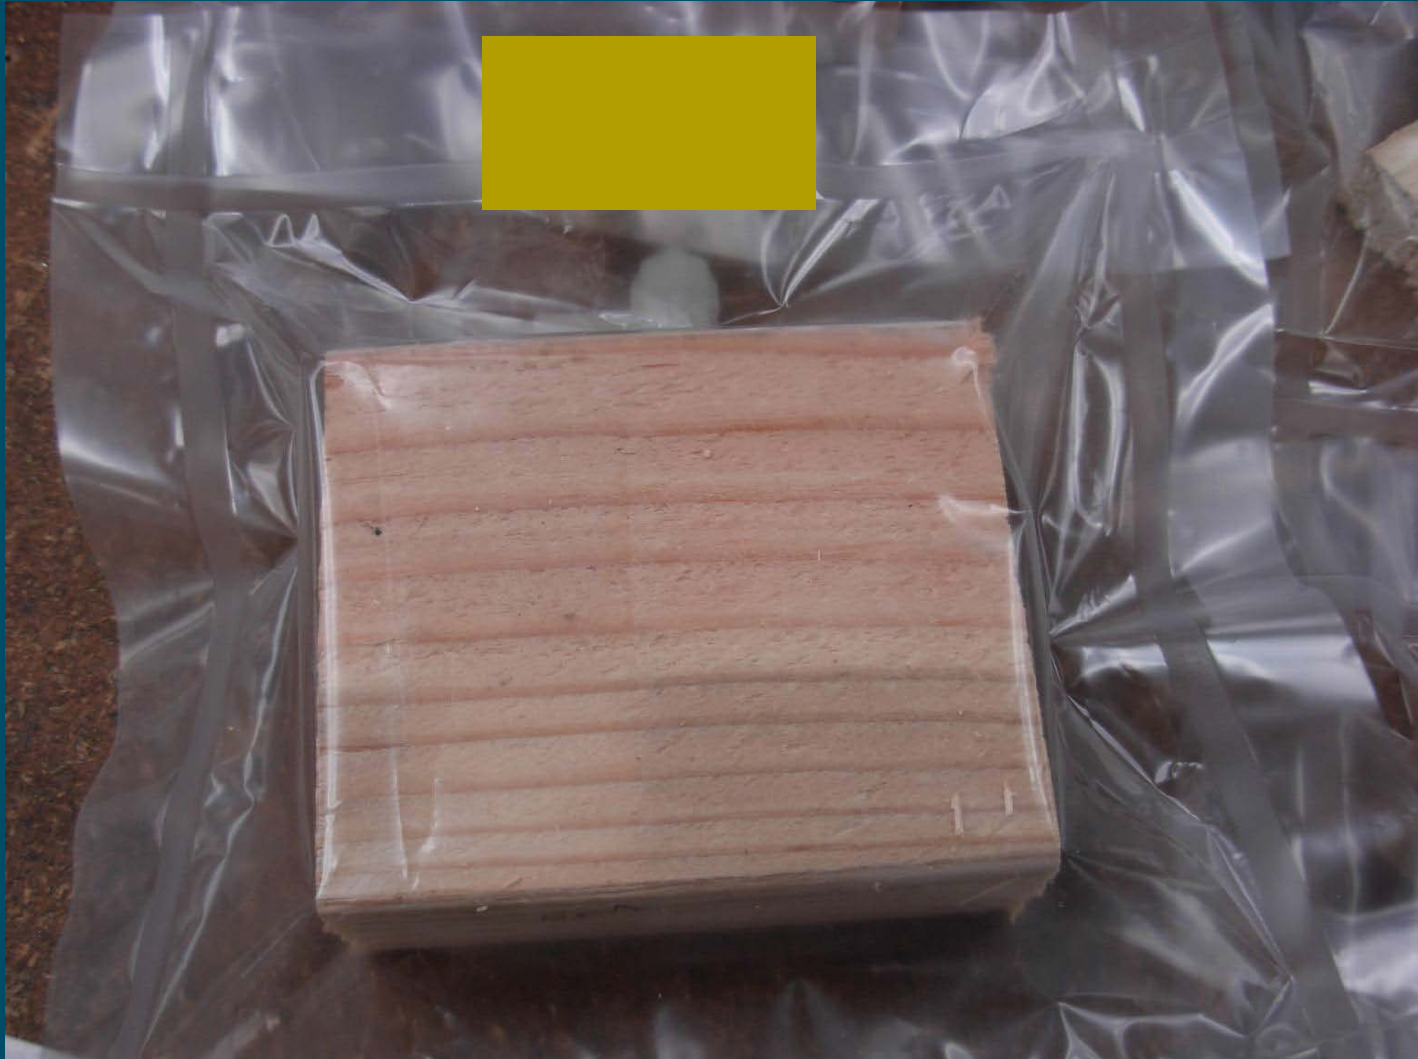
Wood Products

Sampling of wood from 54 homes previously constructed with corrosive imported wallboard does not demonstrate apparently elevated carbonyl sulfide residues reflecting residual gas from the wallboard. Levels are slightly lower than found in new wood products.

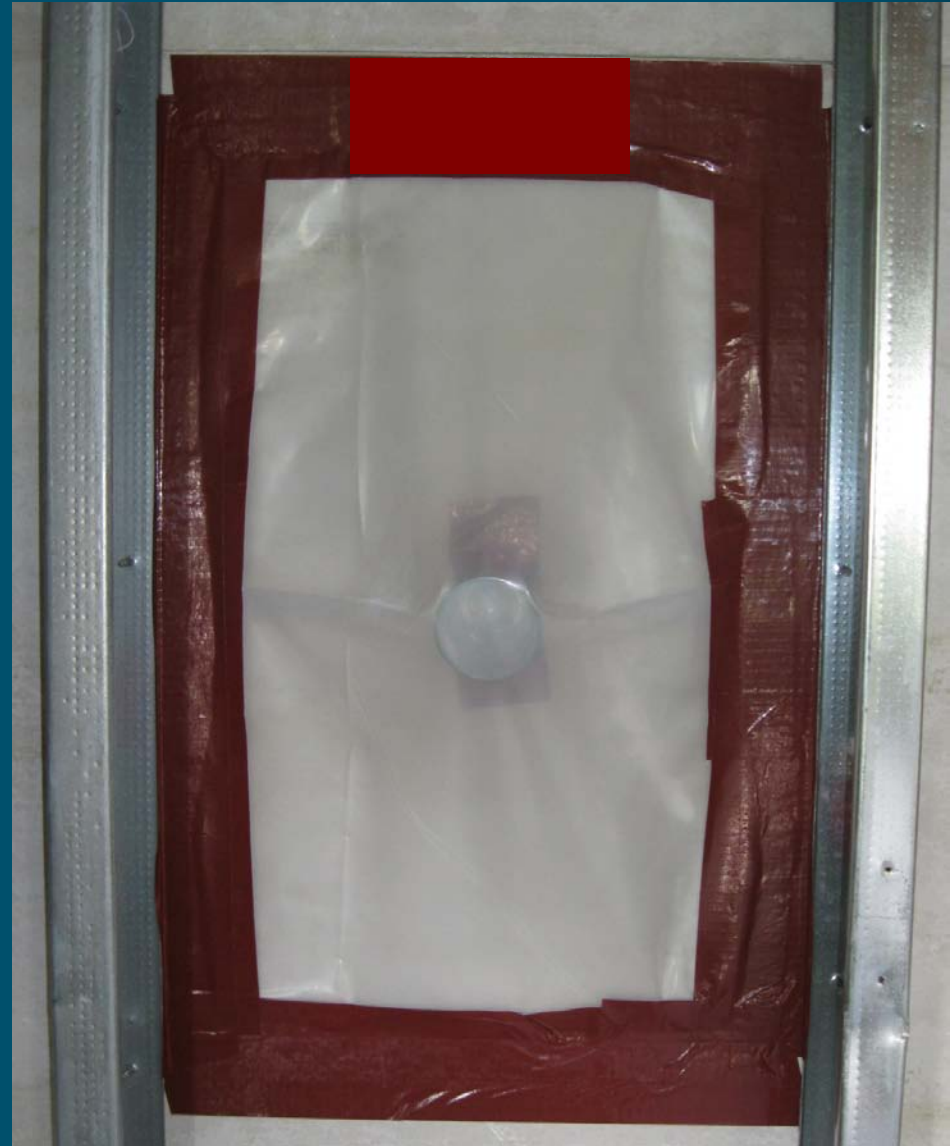
Cementitious Shower Backing Board

- **No detections for sulfide gases were reported in the more than 80 chambers that were placed on cementitious products in homes that previously contained corrosive imported wallboard**

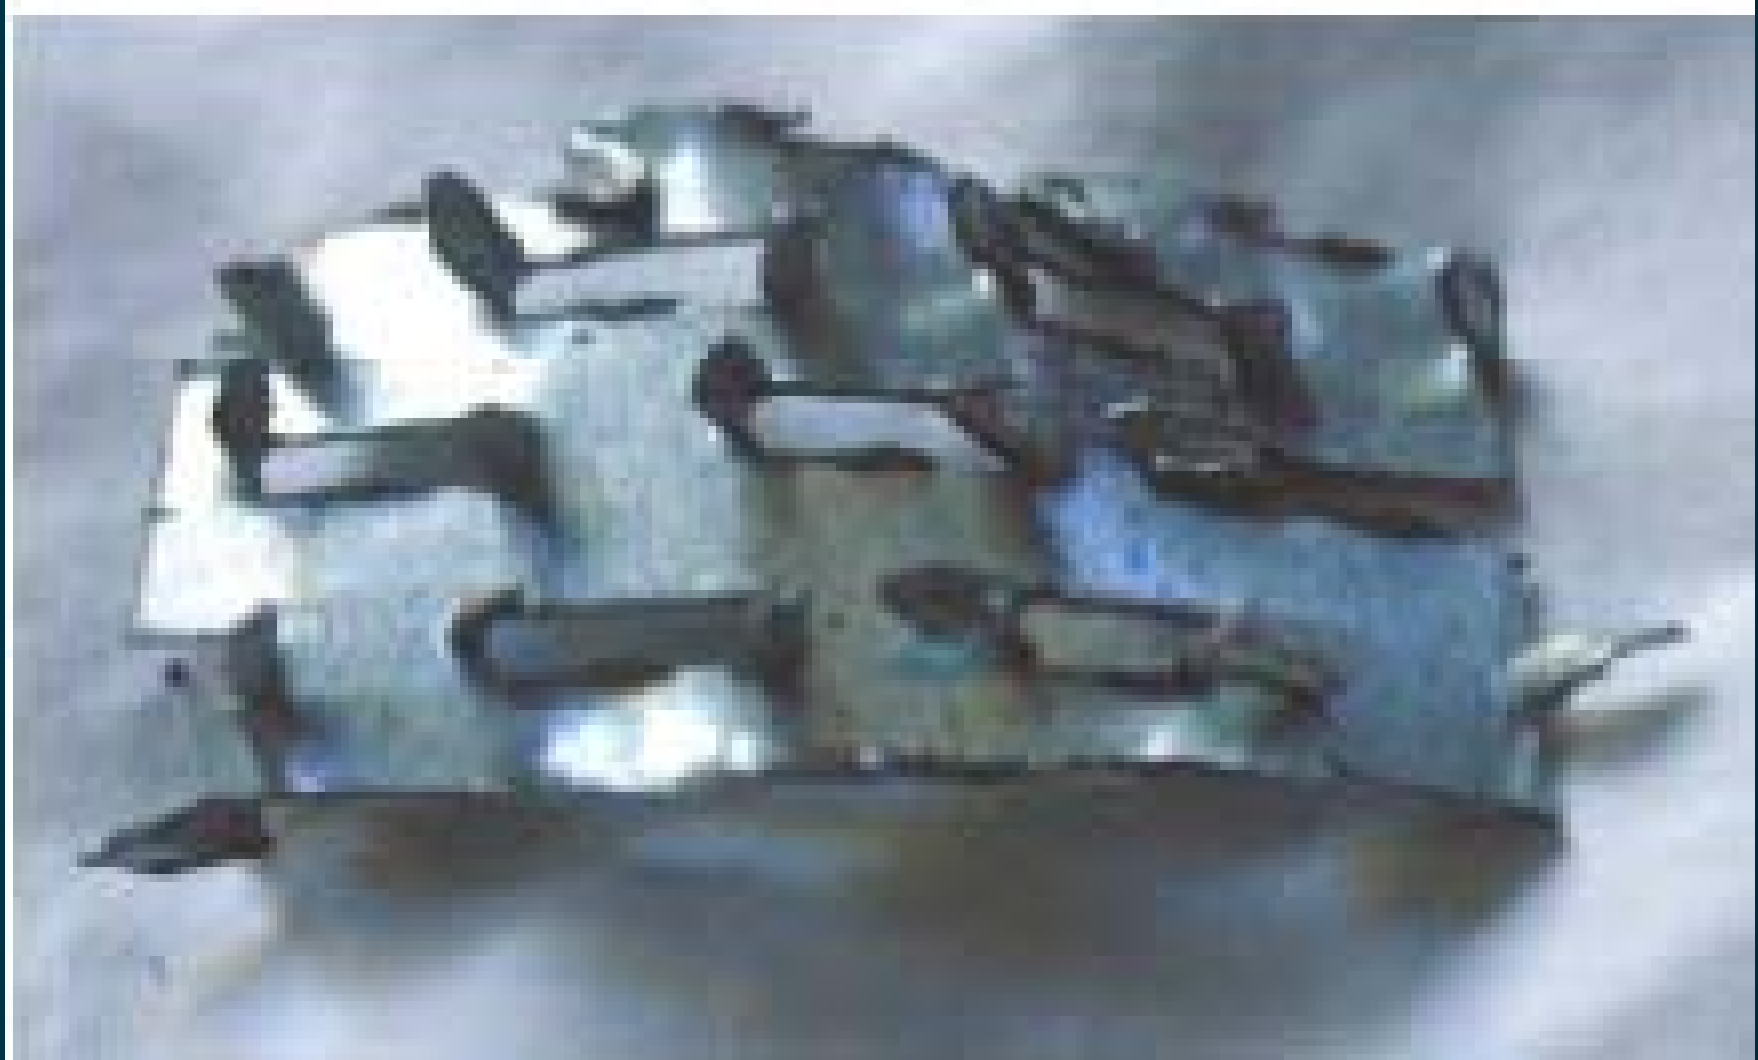
Truss Plates

- **Metal framing components have likewise been evaluated**
 - **mild oxidative effects are expected and may be observed given the continuous presence of oxygen**
 - **Observations via electron microscopy and energy dispersive x-ray analysis are not similar to those observations of affected metals such as copper**
