Copper Metal Corrosion Studies from Diffusion of Sulfur-based Compounds Emitted from Defective Drywall

Spiderman S. Mulholland¹ and Ara Manukian²

U S Building Consultants, Inc., Analytical Research Systems, Inc.
CDUVTCEV"

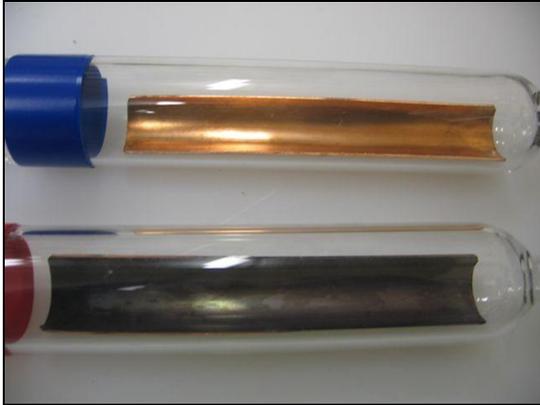
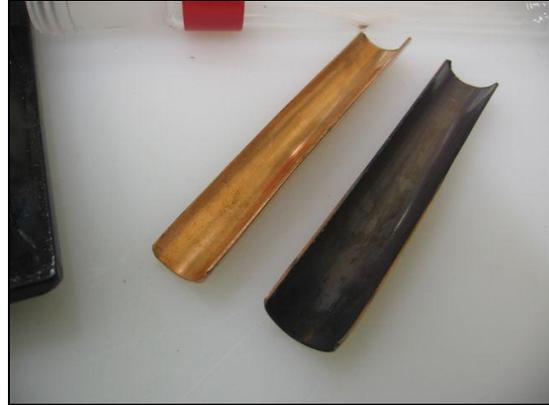
After 3 weeks of air exposure, the Chinese Drywall exposed sample (ID# DD-ER) showed significant black discoloring while the USA Drywall exposed sample maintaining its original copper color (bright copper shine). (SEE PHOTOS)

Subsequent scanning electron microscopy (SEM) with Elemental Energy Dispersive Spectroscopy (EDS) testing was done by the Major Analytical Instrument Center (MAIC) of the Department of Material Science & Engineering (MSE) at the University of Florida (Gainesville, FL), under the supervision of Dr. Amelia Dempere, PhD Laboratory Director, which confirmed high sulfur corrosion product on the Chinese copper sample.

After 3 weeks of air exposure, the Chinese Drywall exposed sample (ID# DD-ER) showed significant black discoloration while the USA Drywall exposed sample maintained its original copper color (single copper strip). (SEE PHOTO'S)

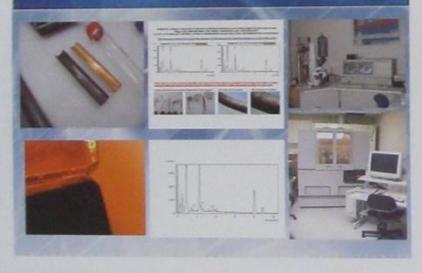
Copper Corrosion Analysis by EDS & X-Ray Diffraction
