Evolution of Chinese Drywall Inspections and Findings Based on Laboratory Data, FDOH Guidelines and the Need to Incorporate New and Productive Inspection Techniques

William H. Spates III, President
Tom Rinicker, Consultant
Timothy Toburen, Consultant

Indoor Environmental Technologies, Inc.
1384 Pierce Street
Clearwater, FL 33756

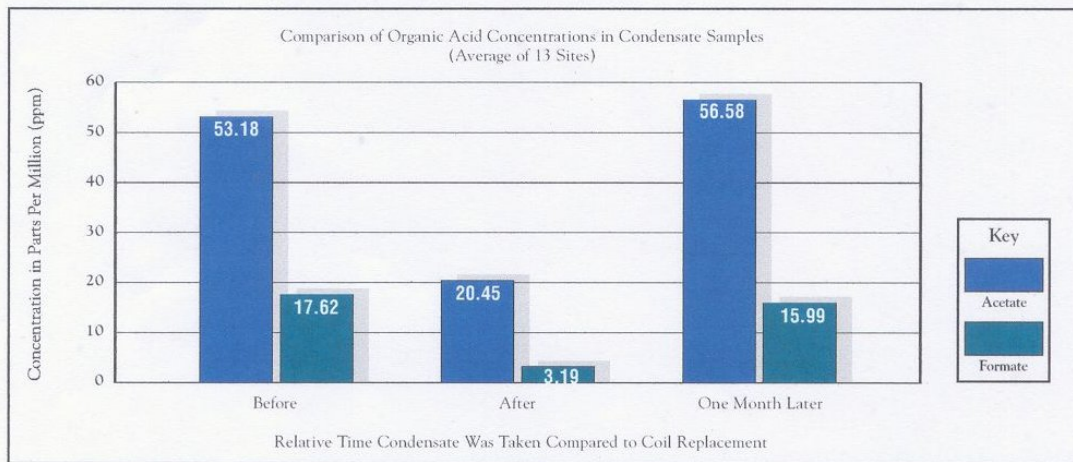
Carrier Article Graph, 2004

implication of Chinese drywall had not surfaced. Our test results were consistent with the Carrier Paper “*Indoor Coil Corrosion*” printed in 2004 implicating fin pack leaks from formicary corrosion. HVAC coil failure did exist prior to the introduction of Chinese drywall to the U S housing market. Carrier’s conclusion stated that the reduction in air exchange (tight buildings) and the use of building materials that off-gas corrosive vapors were implicated.

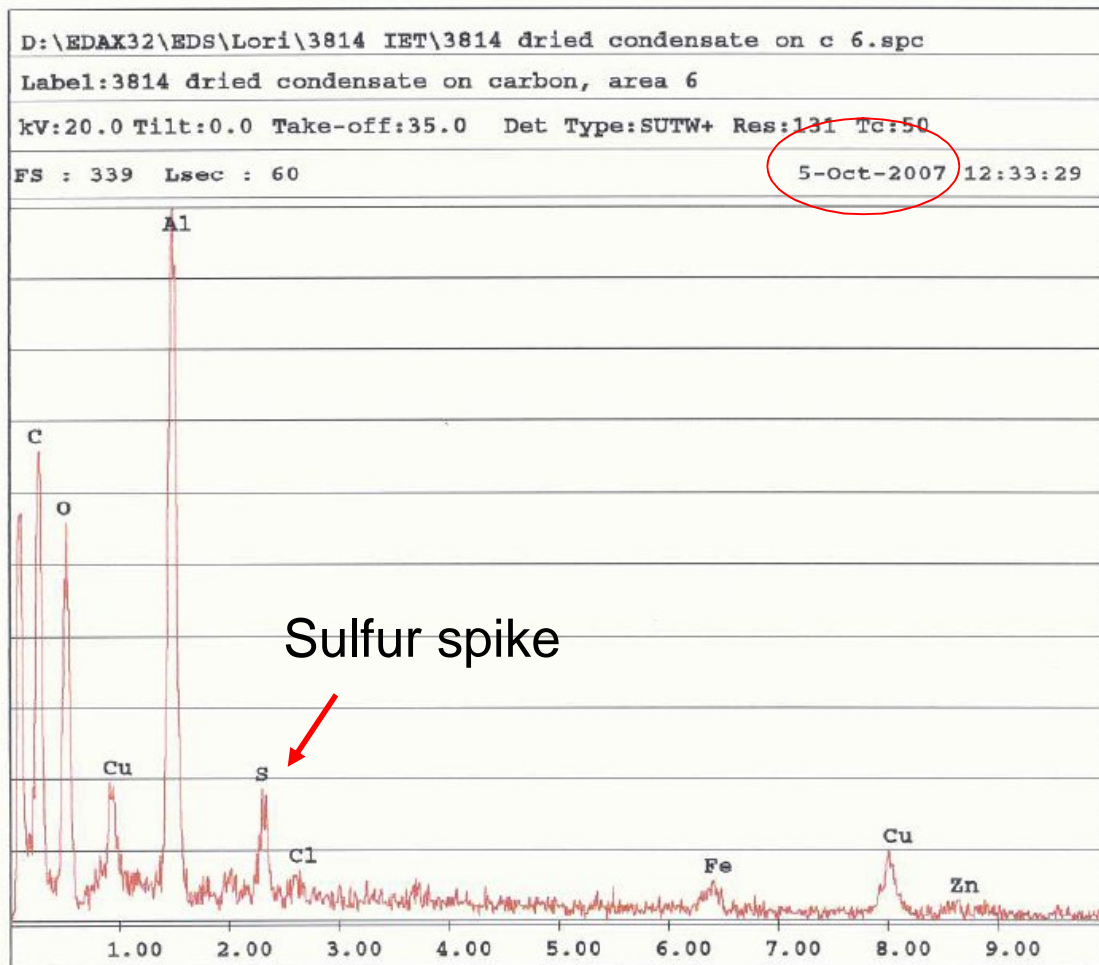
These same samples were analyzed using SEM/EDS microscopy of dried condensate water indicating elevated sulfur compounds.

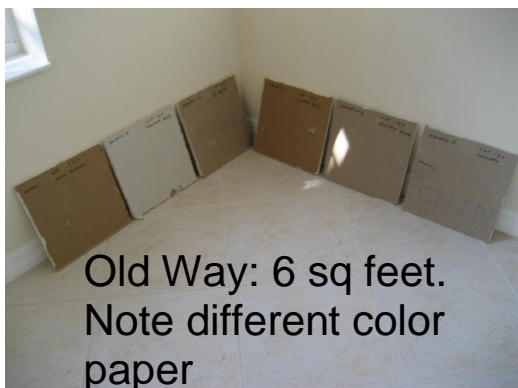
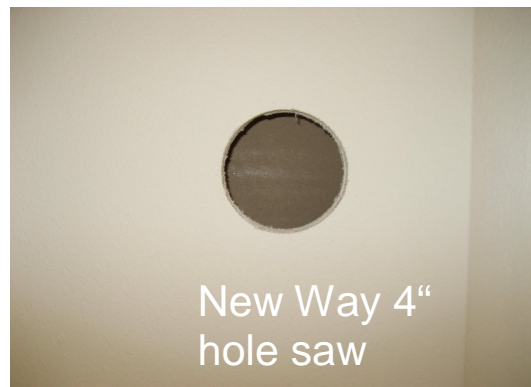
developments in the laboratory analysis of materials. Combined with a building and site history and visual inspection, conclusions can be drawn as to the presence or absence of CDS. We used to cut one foot square pieces of drywall out of walls to look for labels and secure samples for analysis. The theory was that a large enough sample of drywall material placed in a chamber under hot humid conditions could lead to copper corrosion. Well, they didn't, even with drywall labeled Knauf and sampled for over 20 days at 80 degrees and 95% RH. Today we are taking a two inch square piece of drywall, placing it in a zip lock bag and sending it to a lab for Strontium analysis. In the past we used TO15 grab samples and Tedlar bag grab samples for sulfur compounds before we realized that the detection limits for the results were so low as to sometimes be below outside ambient levels. We have stopped performing air samples until we are introduced to a method that is cost effective and productive.

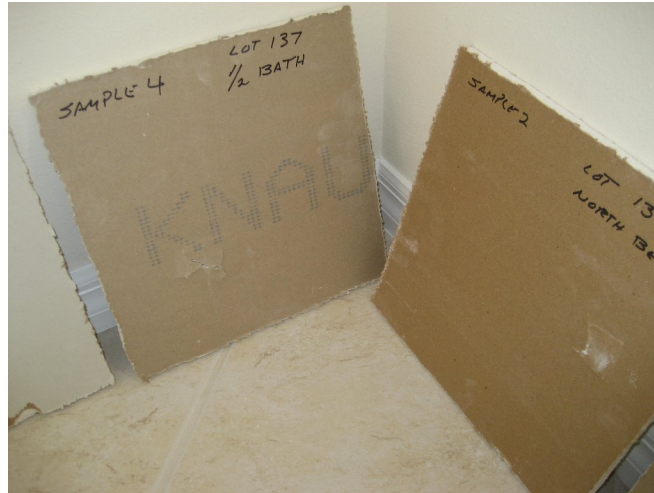
Examples above indicate the different paper backing on Knauf drywall (light gray) and domestic drywall (brown). Different manufacturers have different paper backings and a library of pictures for inspectors is helpful, but not conclusive by any means. Knowing the difference in paper backing when inspecting a home is important.
