Measurement of Corrosive, Odorous and Potentially Harmful Gases from Imported and Domestic Wallboard

**Presentation for:
Technical Symposium on Corrosive
Imported Drywall
November 5th, 2009, Tampa FL**

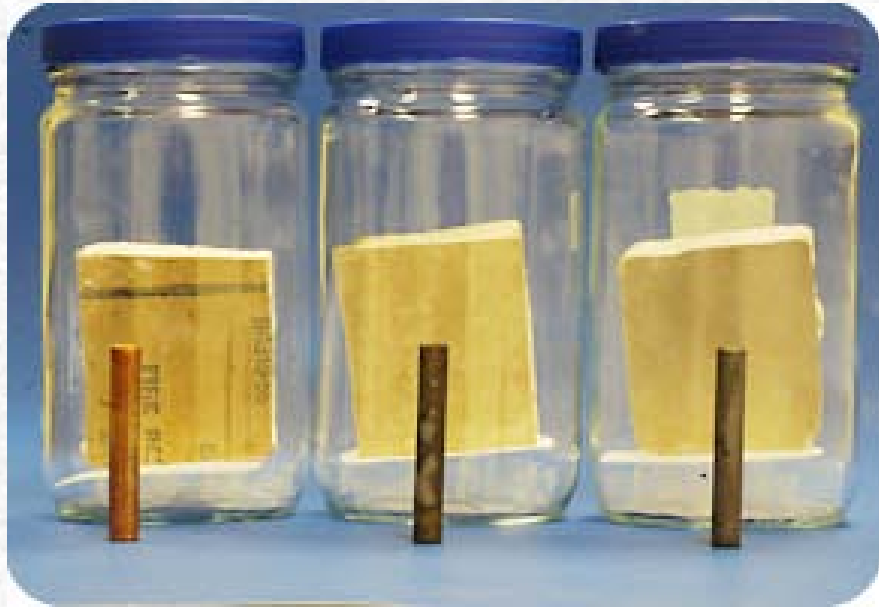
Jar Test: Blackening/Corrosion

- 3" x 3" piece of drywall on platform in 1L glass jar
- 3 mL deionized water
- 3" length of 1/4" O.D. copper tubing (lightly sanded with extra-fine sandpaper to remove surface contaminants)
- "Hot Room" at 37°C
- Blackening/Corrosion evaluation after 21 days

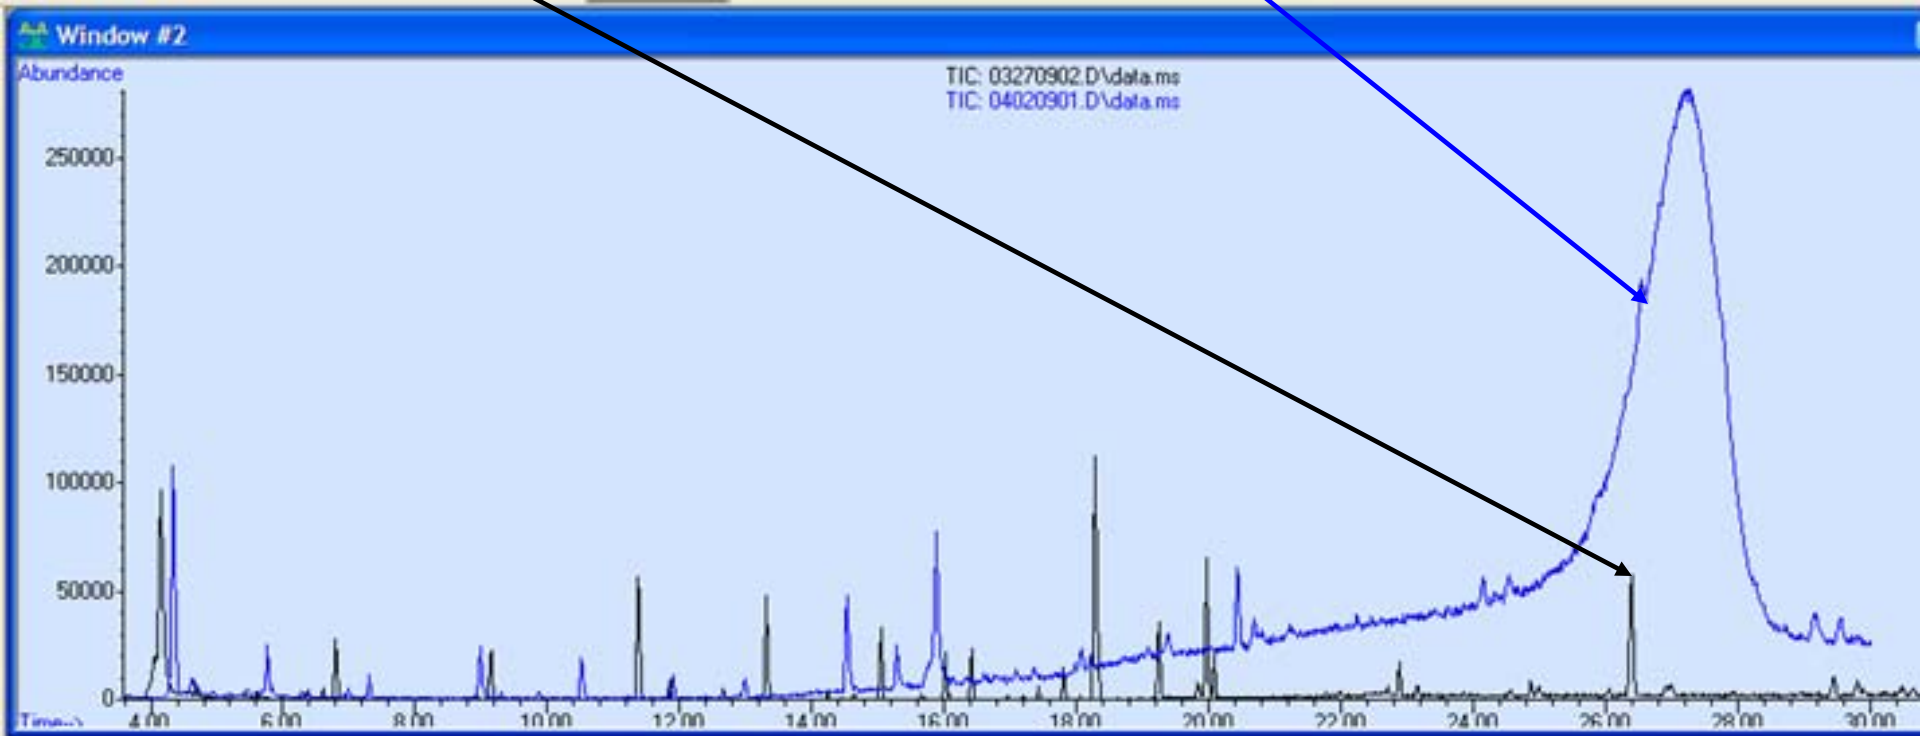
Corrosive vs. Noncorrosive

Direct Thermal Desorption- Gas Chromatography/Mass Spectrometry

Noncorrosive

Corrosive

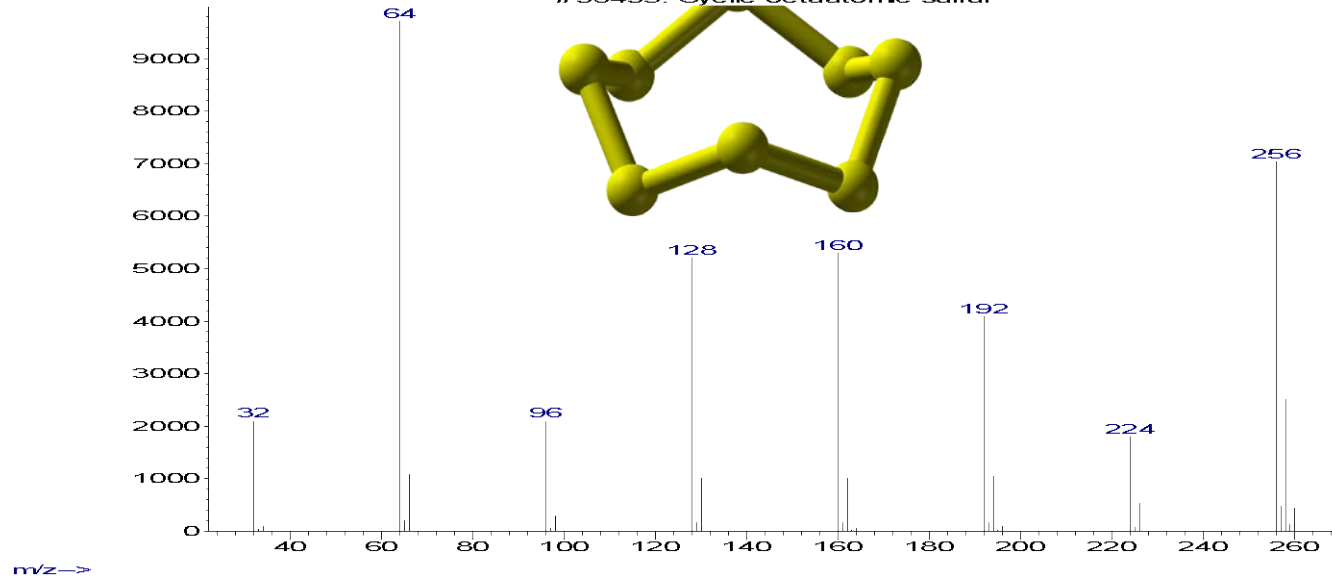
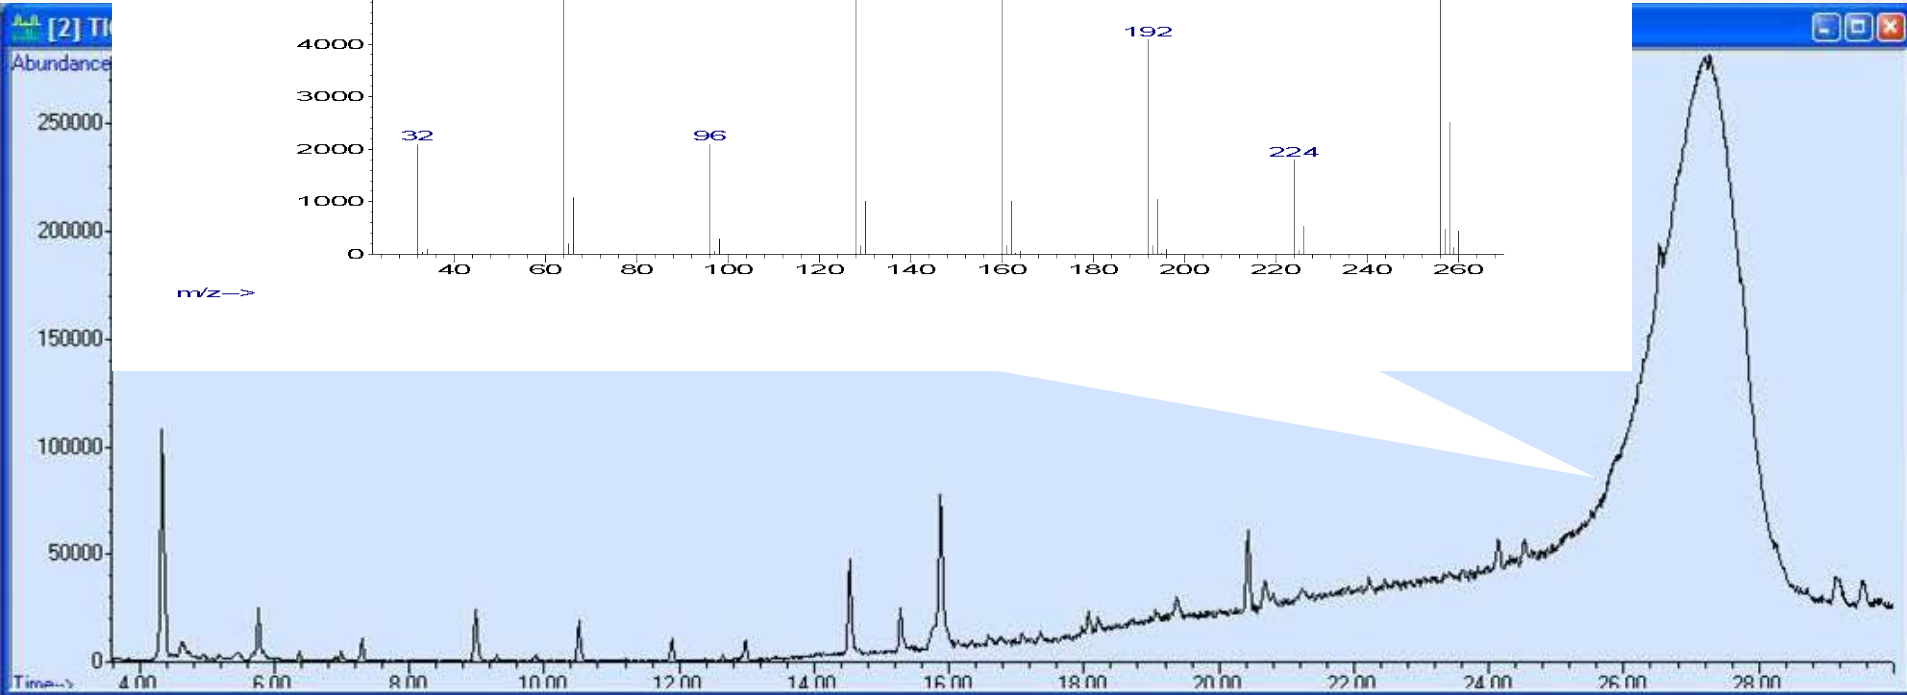
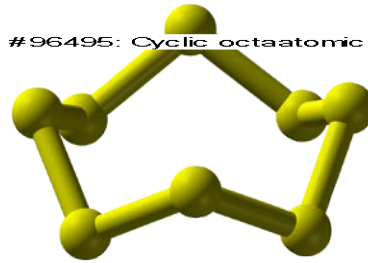
Corrosive Drywall Sample

#96495: Cyclic octaatomic sulfur

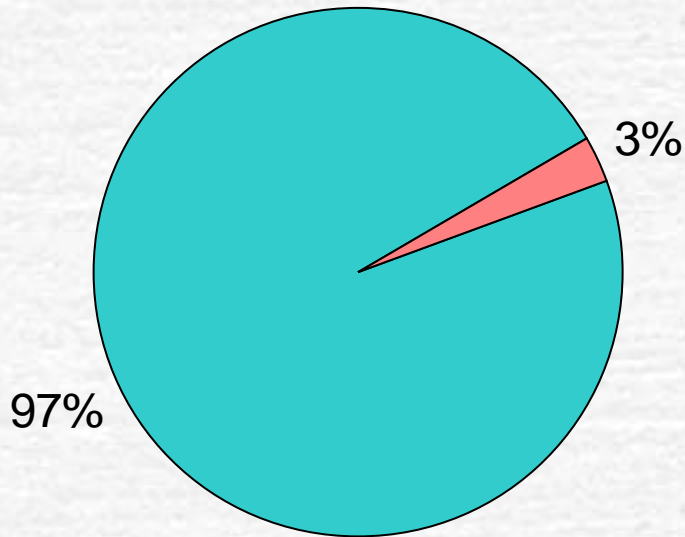
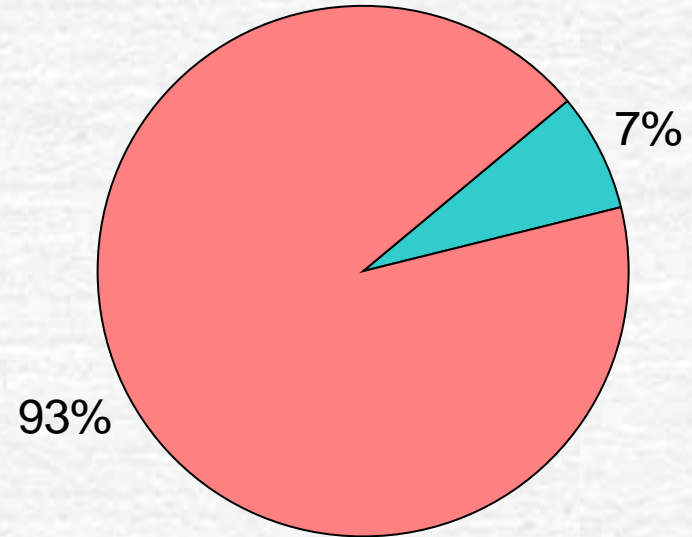
S₈ – Hydrogen Sulfide Relationship

Drywall Samples
(n=228)

Positive S₈
(n=146)

Negative S₈
(n=82)

■ Positive H₂S
■ Negative H₂S

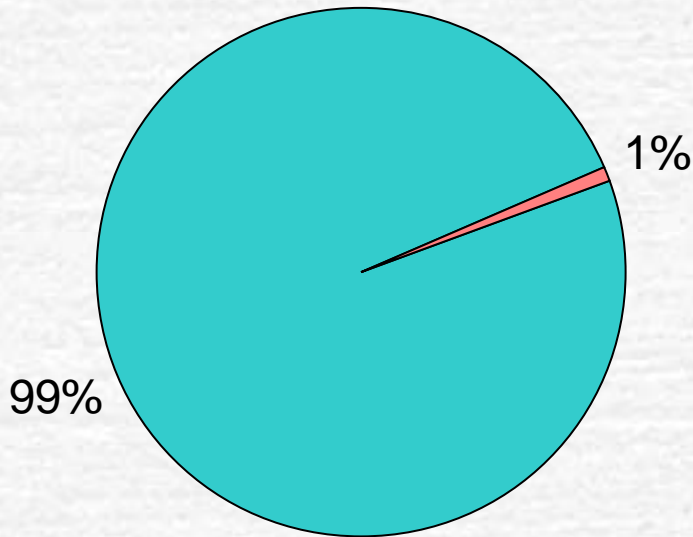
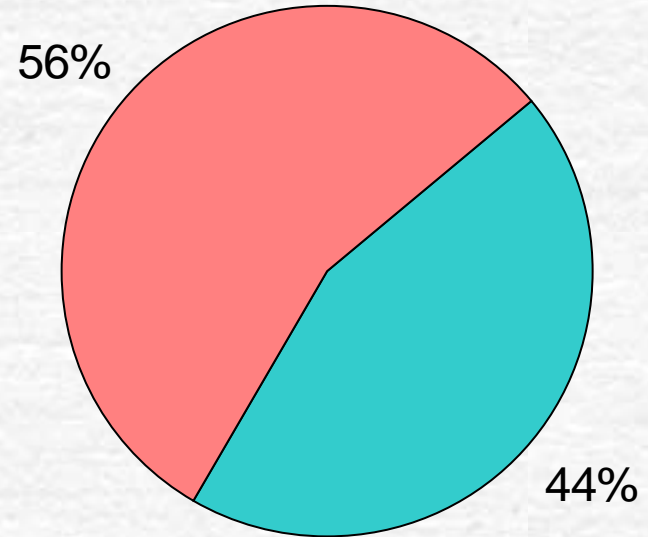
S₈ – Carbon Disulfide Relationship

Drywall Samples
(n=148)

Positive S₈
(n=103)

Negative S₈
(n=45)

■ Positive CS₂
■ Negative CS₂

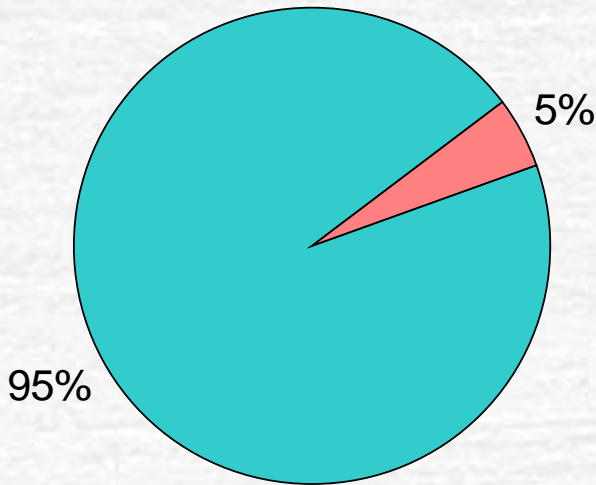
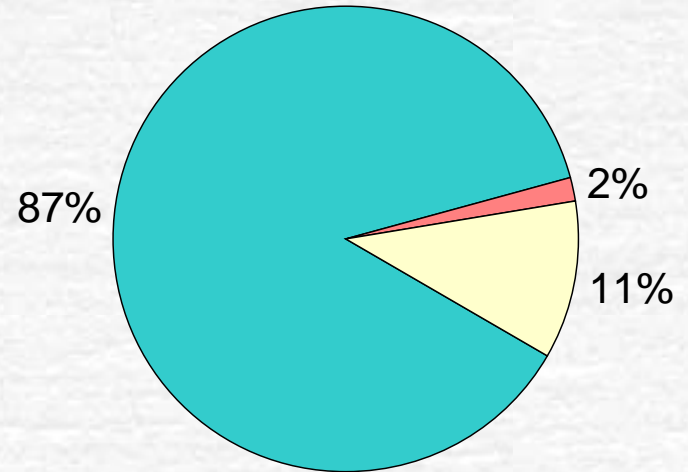
S₈ – H₂S – Blackening/Corrosion

Drywall Samples
(n=143)

Positive S₈
(n=87)

Negative S₈
(n=56)

- Positive H₂S & Positive Blackening/Corrosion
- Negative H₂S & Positive Blackening/Corrosion

- Negative H₂S & Negative Blackening/Corrosion
- Negative H₂S & Positive Blackening/Corrosion
- Positive H₂S & Negative Blackening/Corrosion

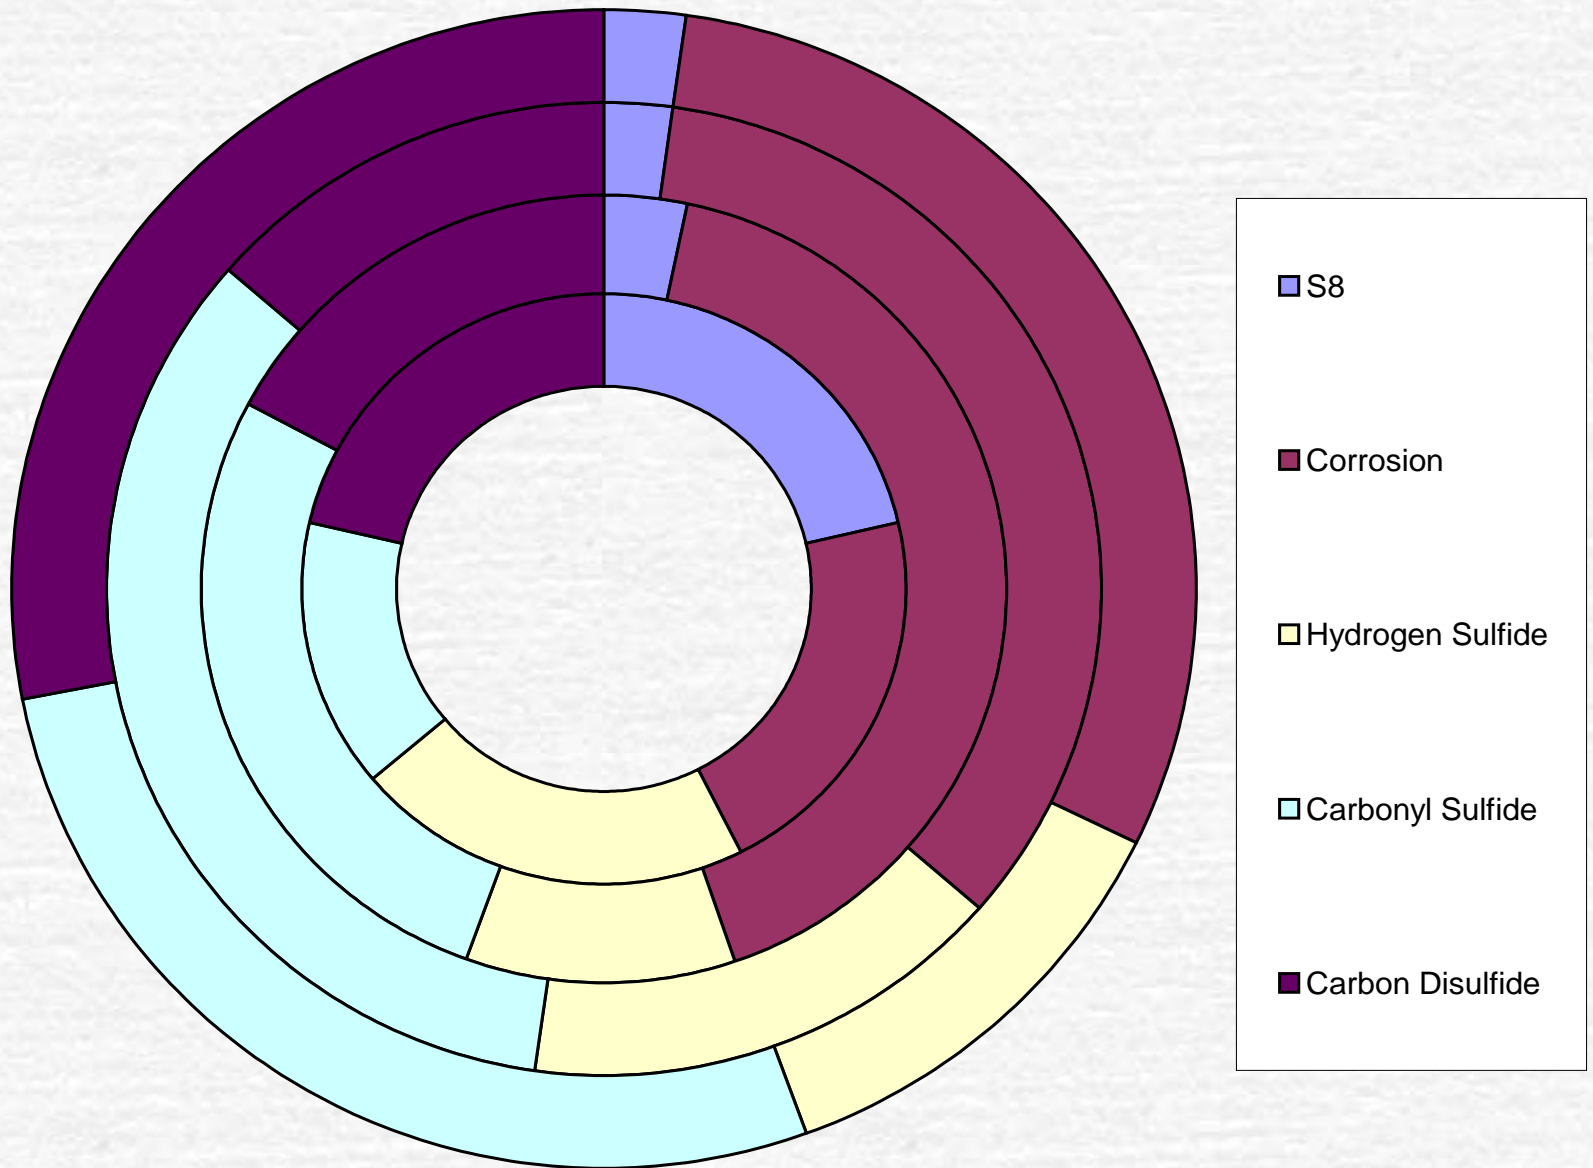
Comparison of Four Corrosive Drywall Samples

- Three samples of noncorrosive drywall
 - Domestic (2 brands)
 - Imported from Mexico
- Four samples of corrosive drywall
 - Imported
- Analysis:
 - Elemental Sulfur
 - Reduced Sulfur Gases
 - Jar Test: Blackening/Corrosion

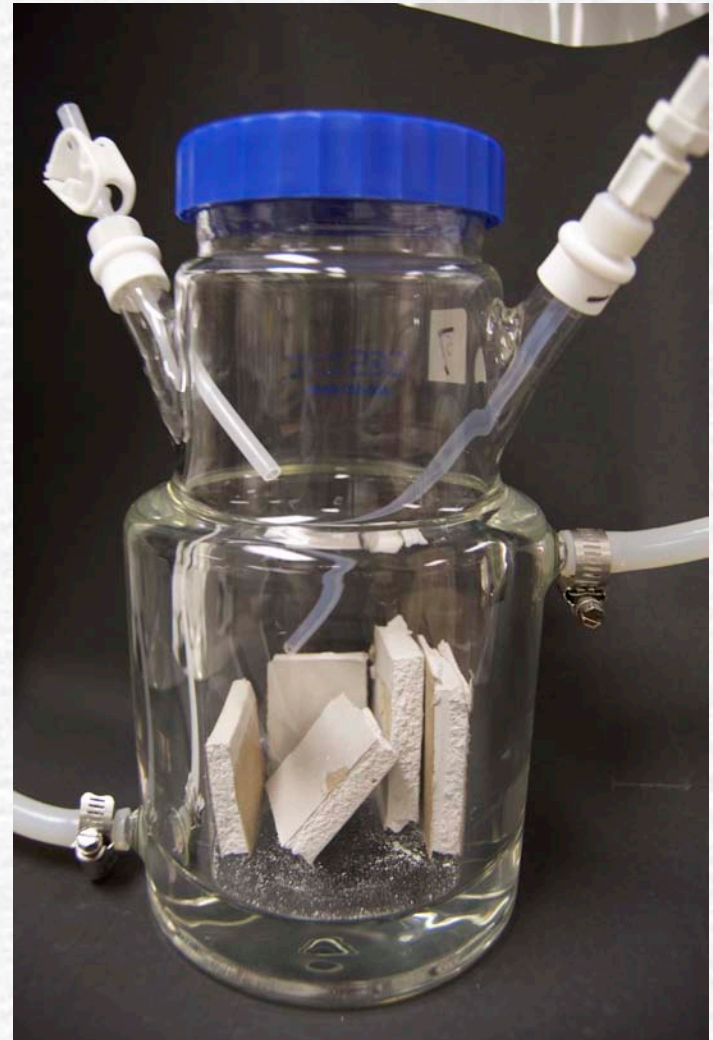
72 hour Static Chamber Studies

- Carboxylic Acids
 - In-House method (GC/MS)
- Aldehydes
 - EPA TO-11A (HPLC)
- VOCs
 - EPA TO-17 (GC/MS)

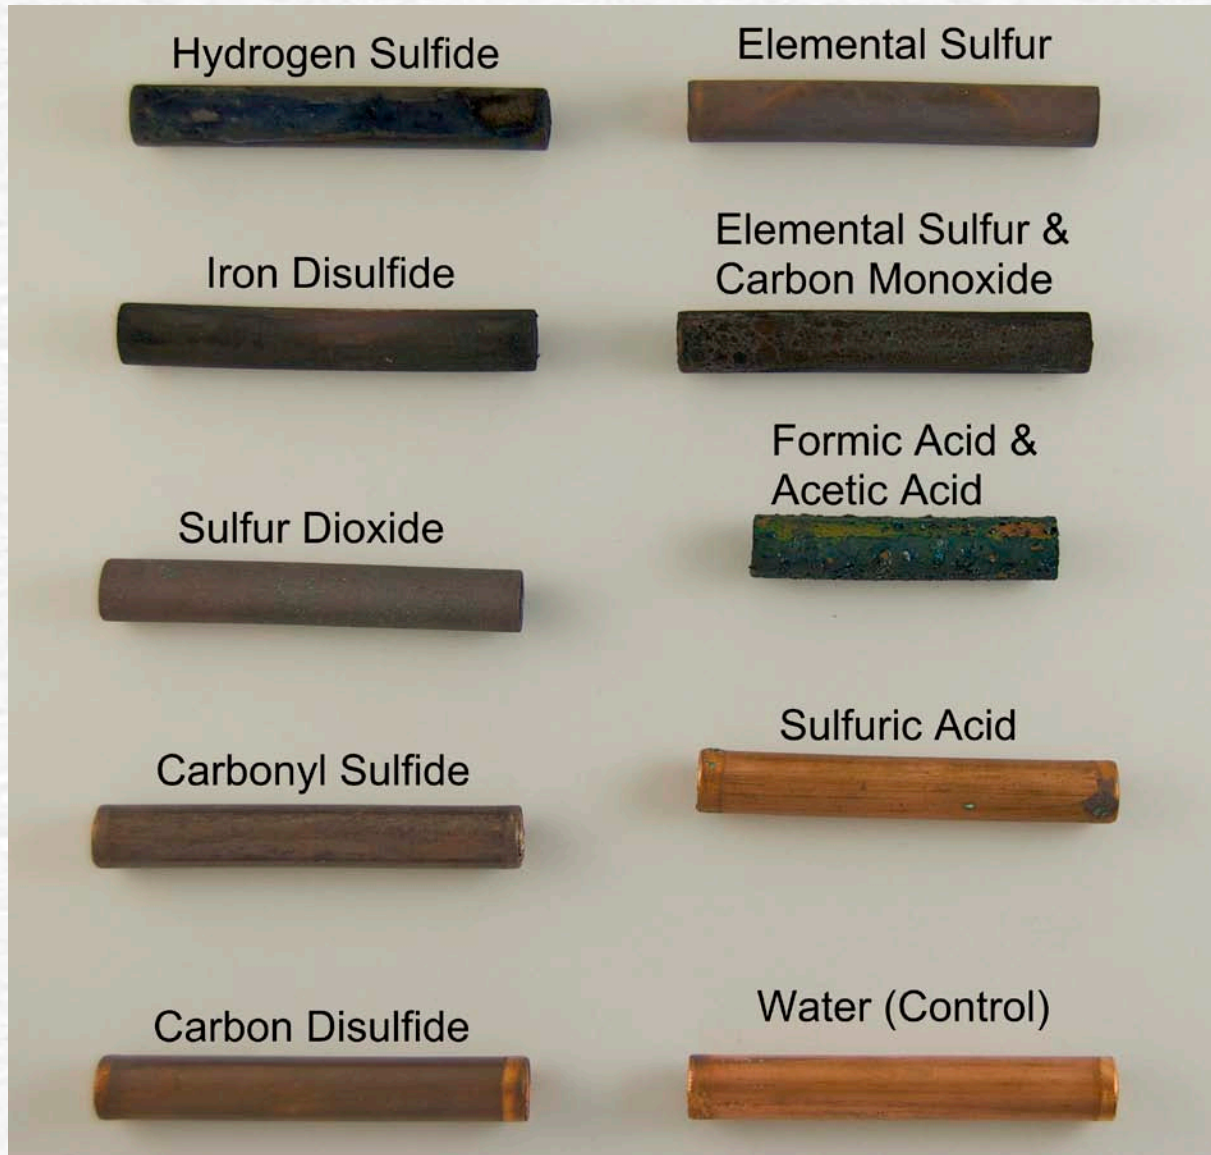
Jar Tests: Blackening/Corrosion

- Elemental Sulfur test can be used as a reliable marker for corrosive drywall
- Blackening of copper is consistent with sulfide attack
- Corrosion phenomenon appears to be a two pronged mechanism: sulfide attack + formicary (ant's nest) corrosion
- Based on the results of our chamber tests, hydrogen sulfide, carbonyl sulfide and acetic acid appear to be the main culprits

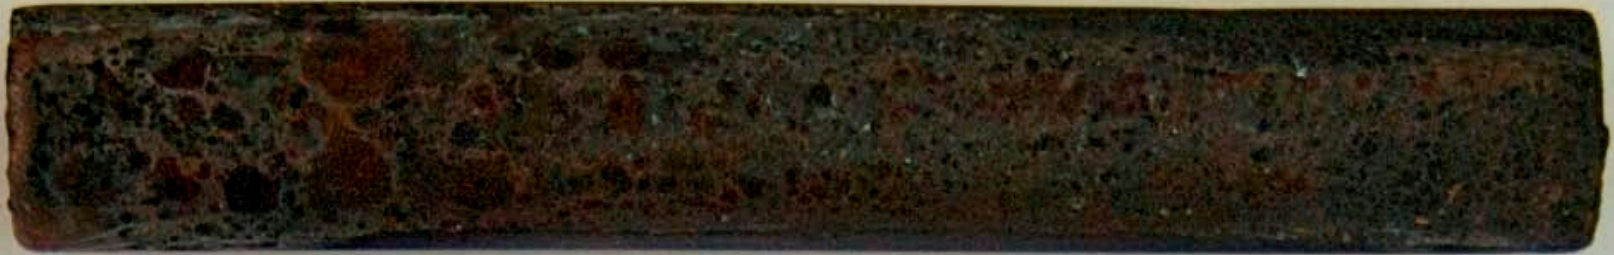
Jar Tests: Blackening/Corrosion

Elemental Sulfur & Carbon Monoxide
