Corrosive Imported Wallboard: Investigating Emissions

Robert P. DeMott, Ph.D., DABT

ENVIRON International Corporation

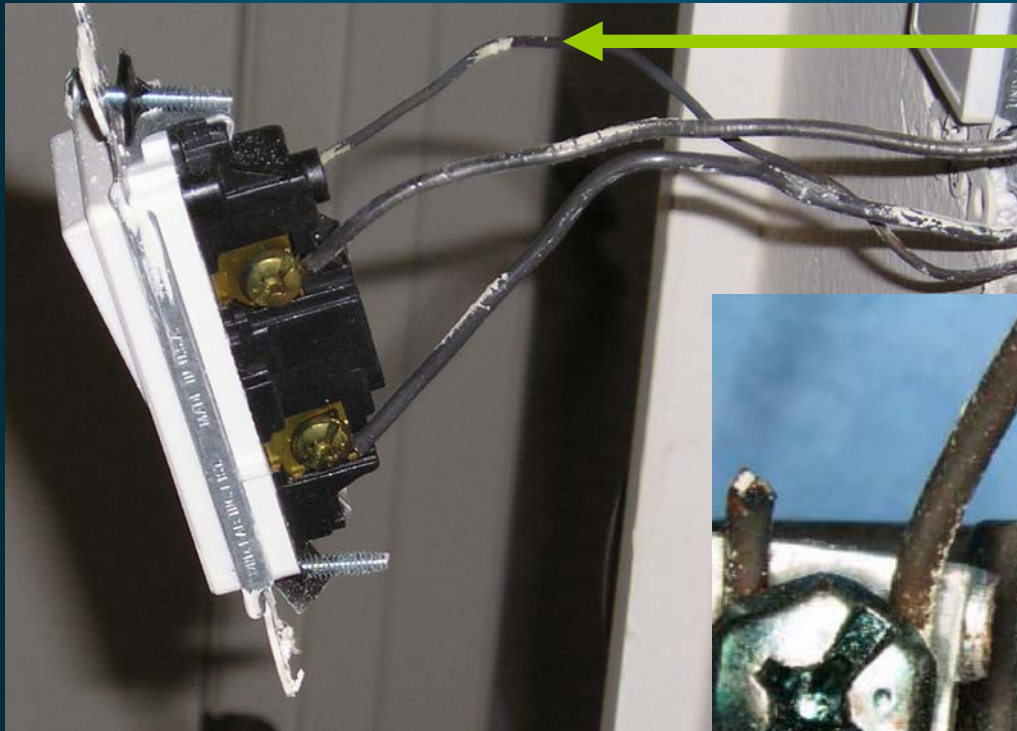
- Corrosion residues are **SULFIDES** (black), not sulfate (greenish blue)
- Hydrogen sulfide (and other sulfides) form corrosive acids themselves
- Importance:
 - Need to focus on remedies that work on sulfide gas releases, not sulfates

Receptacle Showing Residue

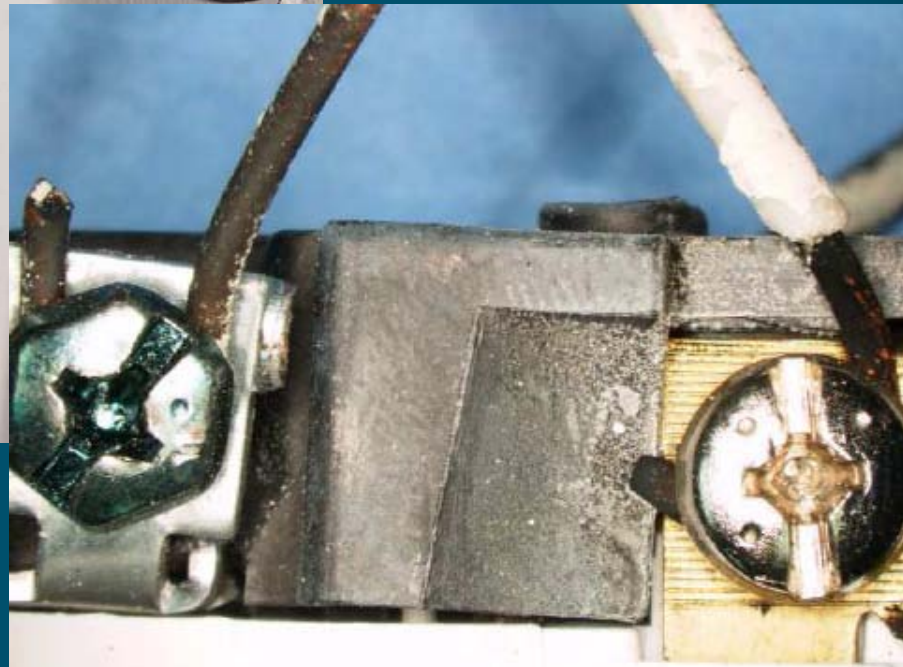
Un-insulated
Ground
Conductor

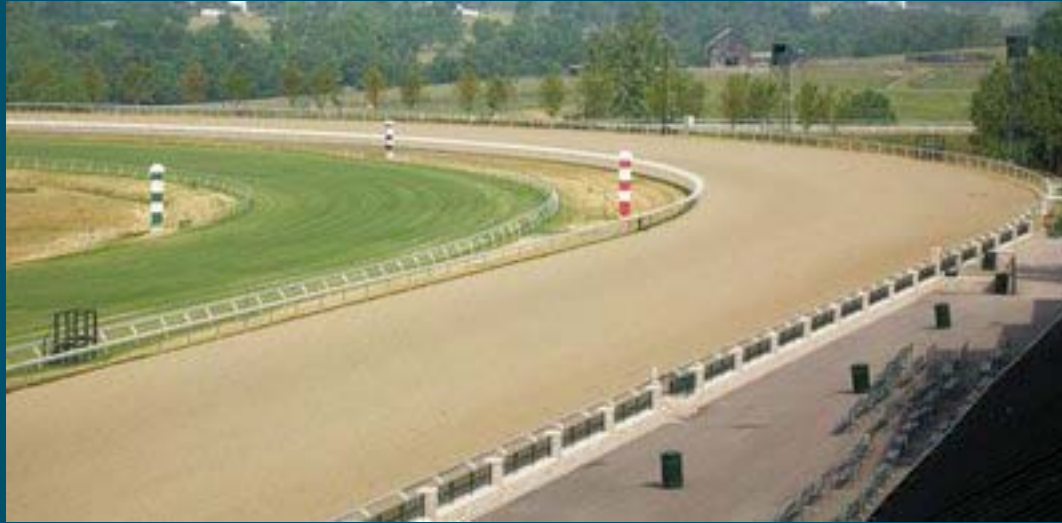
It Takes Energy to “Jump the Rail”

**Conversions among chemicals in the same state
“easier” than jumping oxidation states –
specialized conditions/energy required**

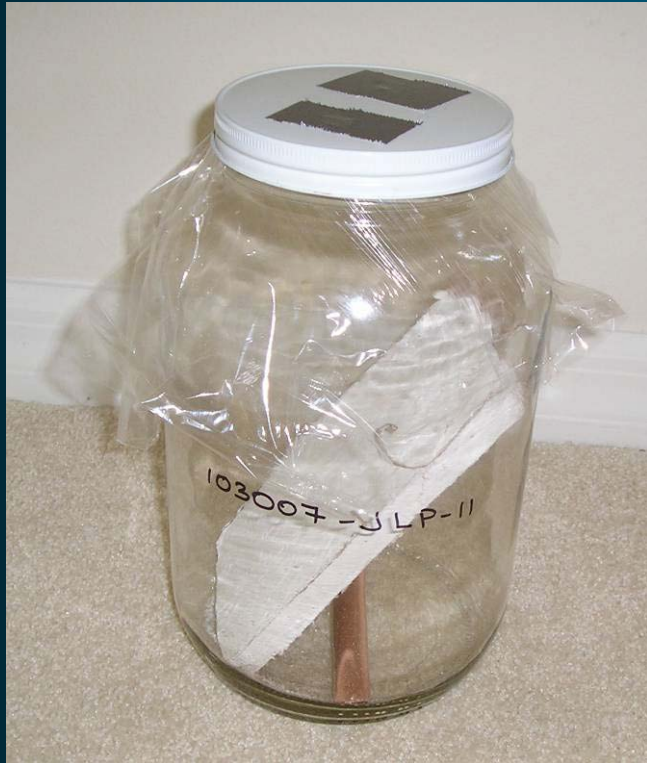
Chamber Test of Sulfide Gas Emissions & Corrosion Potential

- Chinese and domestic wallboard placed in sealed jars with:
 - new, clean, polished copper plumbing pipe; and
 - moist sponge (humidity source).
- Gases sampled at week 18.

- Laboratory analysis (ASTM D-5504) showed carbonyl sulfide, carbon disulfide elevated in Chinese board chambers

Carbonyl Sulfide ($\mu\text{g}/\text{cm}^2$)	Carbon Disulfide ($\mu\text{g}/\text{cm}^2$)
Chinese (n=4)	228	249
Domestic (n=2)	26	58

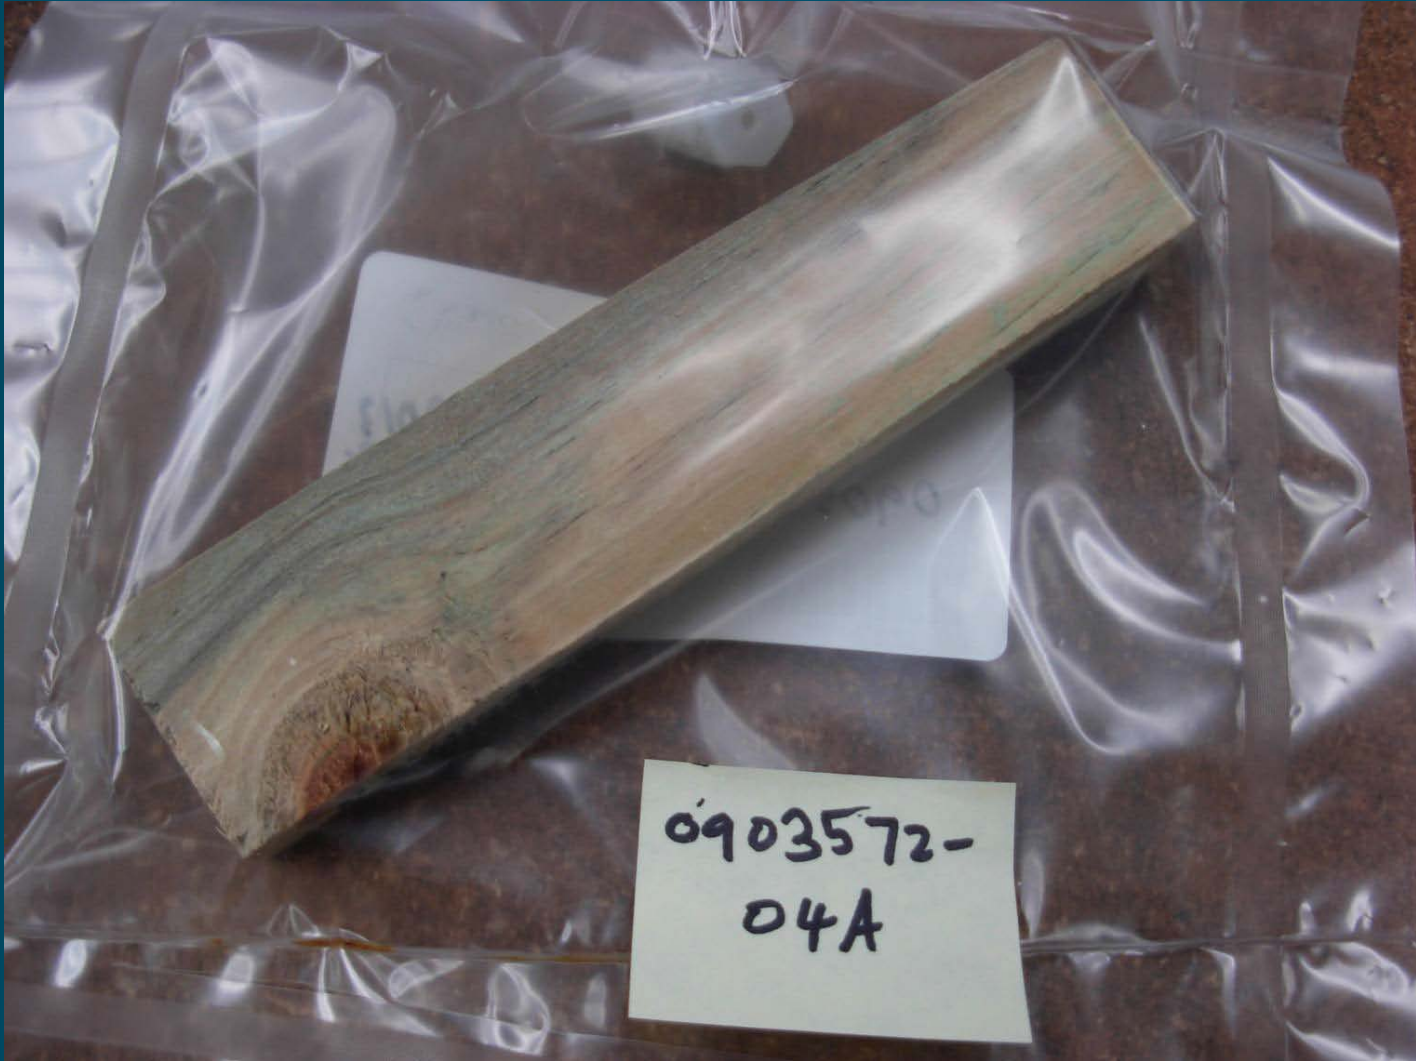
- Plywood, pressure-treated furring strips, framing lumber sampled
 - **54 affected homes under repair, post-ventilation**
 - **2 unaffected homes**
 - **5 retail sources of new materials**
- Sealed in Tedlar bags with 200 ml humidified, zero air
- Equilibrated 24 hrs, 34°C, analyzed ASTM D-5504

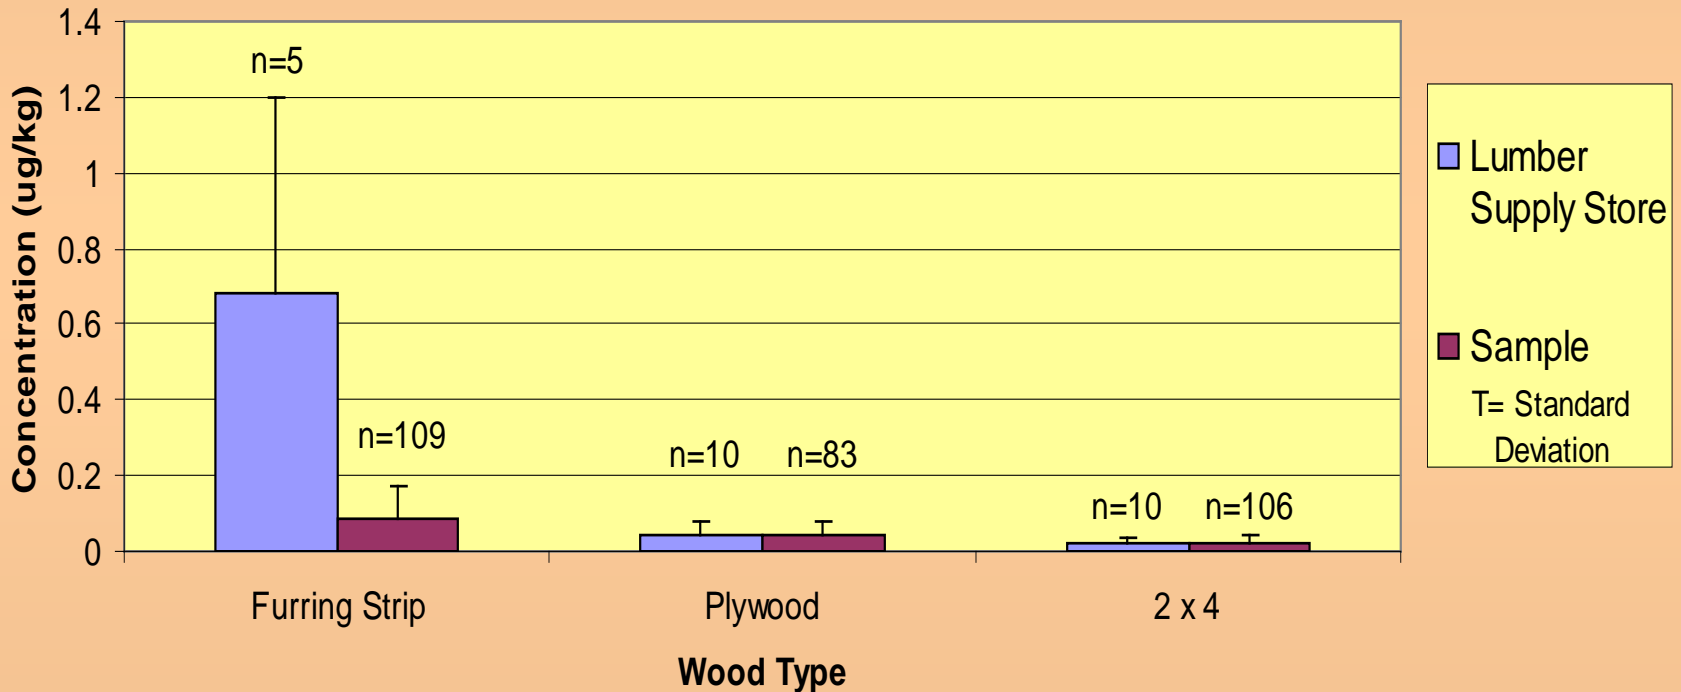
Comparison of Wood Types

Average mass of carbonyl sulfide emitted per kg of wood (ug/kg)

- **Carbonyl sulfide frequently detectable in all types of wood products, both in controls and home samples**
- **Carbon disulfide infrequently detected – but similarly low in controls and affected home samples**

- No statistical difference between carbonyl sulfide concentrations in control samples and samples from homes that contained corrosive defective drywall ($p > 0.05$)
- Pressure-treated wood contain highest carbonyl sulfide concentrations
- Number of detected results from unaffected homes was too low for use in statistical comparisons
 - Average detected levels similar to other groups
(Furring Strip = 0.037; Plywood = .072; 2 x 4 = 0.043 $\mu\text{g}/\text{kg}$).
